Clapperentale Waterwheel Restoration (Escot Park) 2019 / 2020

A Tale Valley Trust Project -

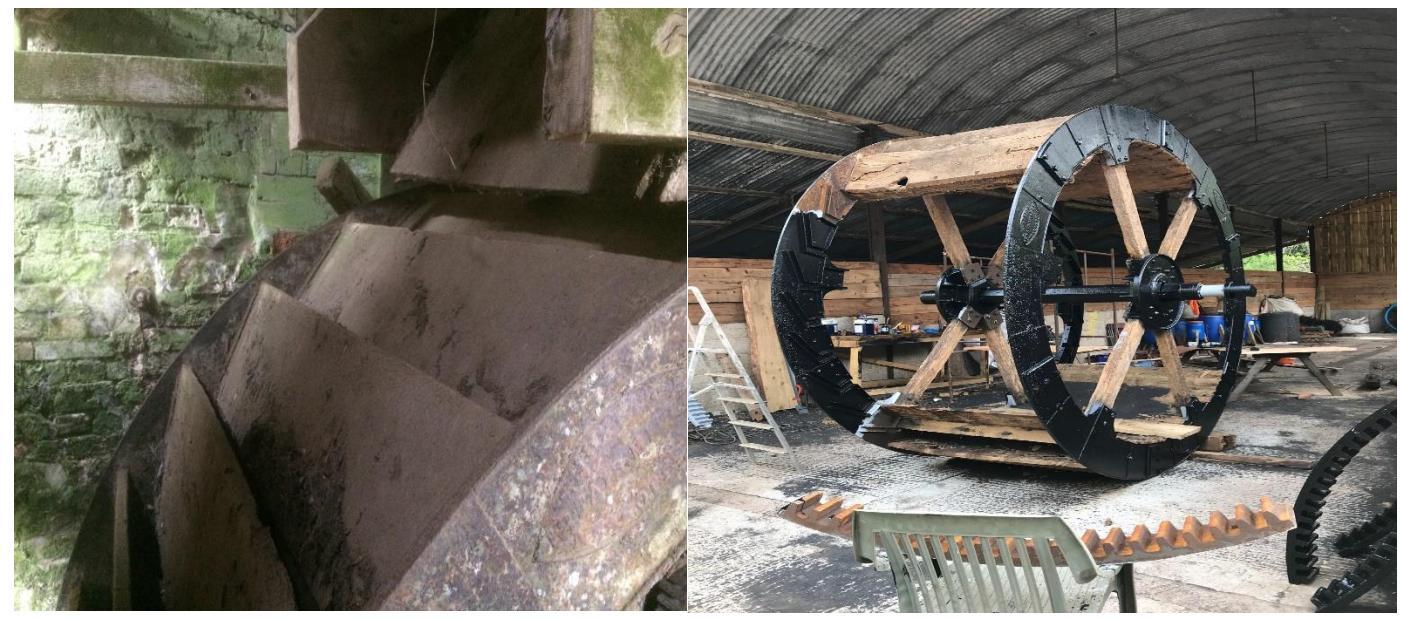
On March 5th we exposed a vertical brick access shaft going down behind the wheel. It had been thought that there was an unexplained culvert leading away uphill from the wheel but in fact it is a beautifully crafted curved bend to the shaft that no-one living knew about! Because the gap behind the wheel had been filled with agricultural rubbish over the years it was not possible to access this area until the wheel had been removed. An exciting discovery!

The wheel was protected (and hidden!) by a tiled roof which had to be removed. A beautiful but self-seeded weeping willow growing out of the foundations sadly also had to go. On February 27th 2019 the wheel was craned out of its sump and placed in an adjacent barn so that it could be worked on.

The exit tunnel, 24 metres of arched brick with a brick floor, had caved in over time at the lower end, so careful mechanical excavation was necessary to re-discover it.

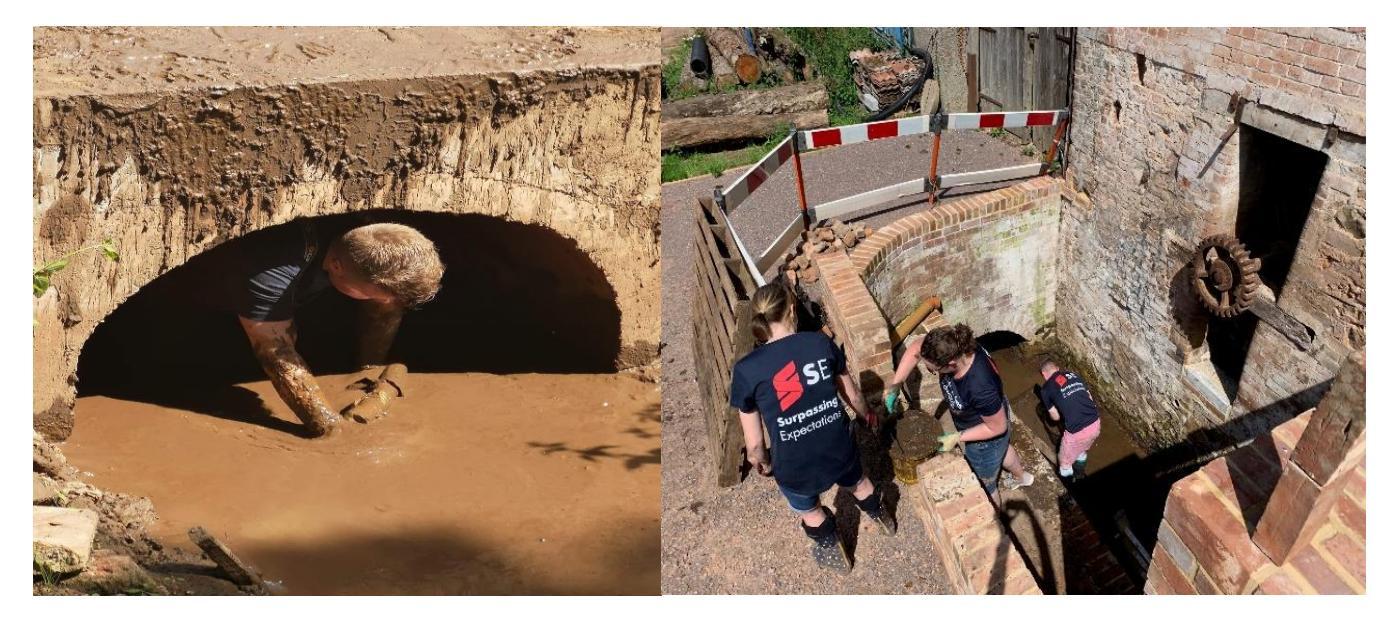
In early May half the wheel was stripped down and the metalwork sandblasted, primed and painted. This was to avoid the risk of the metalwork twisting if all the woodwork was removed at once. Brickwork surrounding the wheel was repaired and new pedestrian steps created where the willow tree had been. By the end of the month the first bucket of the wheel had been renewed, using Escot larch, felled and milled on site. On May 24th a small channel just wide enough to allow crawling was cleared through the silt in the brick tunnel to allow excess water to escape and for the mud to dry out as much as possible. This paved the way, literally, for a fantastic group of volunteers to spend a day in June, clad in chest waders, crawling in relays with buckets passed down the line to remove 5 dumper loads of mud!

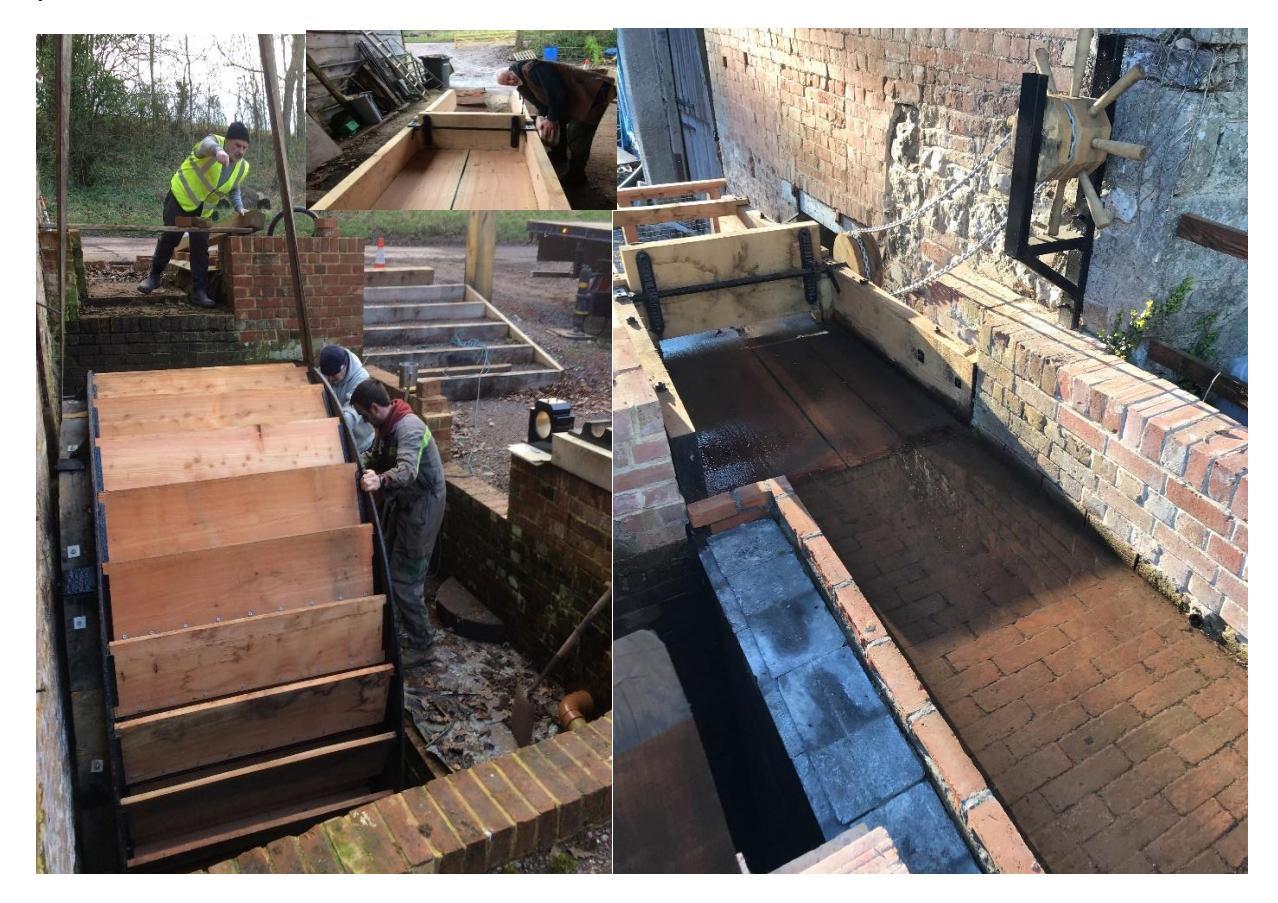
On February 10th 2020 the restored wheel was craned back into position and final adjustments were carried out in situ. By mid-March the new launder was also craned into position over the wheel.

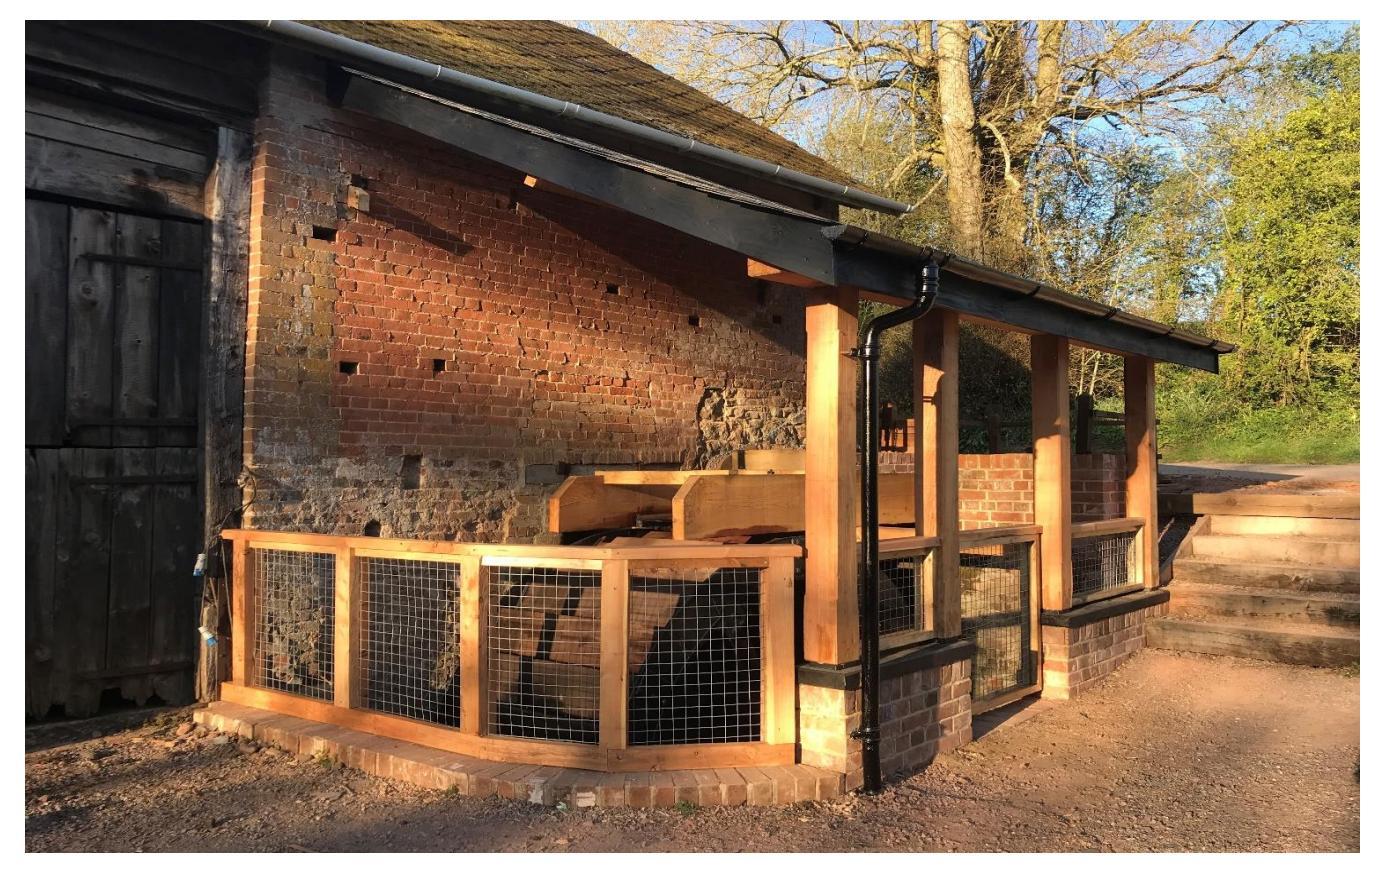
On March 26th the water pump was switched on and the wheel spun on its axis for the first time in 86 years! However, the volume of water wasn't *quite* sufficient. The wheel would spin for 1.5 revolutions and then have to stop for a drink. A second pump has rectified that! The combined flow rate is now 15 litres / second.

By the end of March scaffolding was erected over the wheel so that the protective roof could be rebuilt. By Good Friday, April 10th 2020 the roof was complete, scaffolding removed, and the project flowered!
